Manhole Inspection Summary

Manhole # S45E2_030MH

Insp Date: **1/15/08 12:48 PM**

Location Address: **1603 Pennington-morrison**

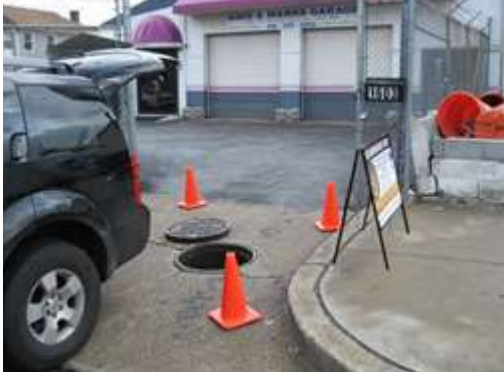
Location View

1603 Pennington-Morrison

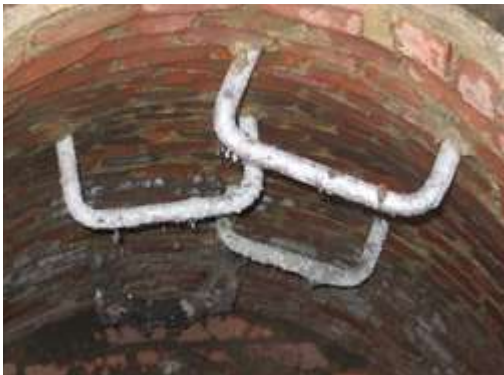
Steps Count: **4** Missing: **0** ☐ Corroded

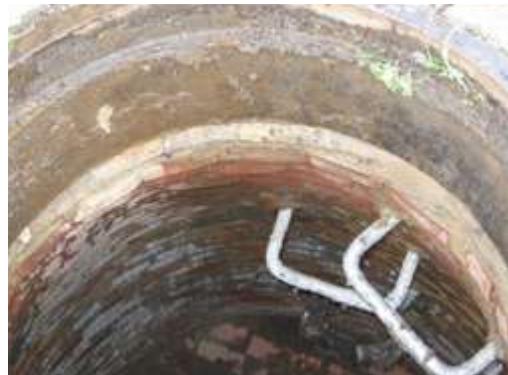
Defect 2

Frame Offset: **0.5** (in.) Condition: ☒ Sound ☐ Cracked ☐ Leaks

Frame offset

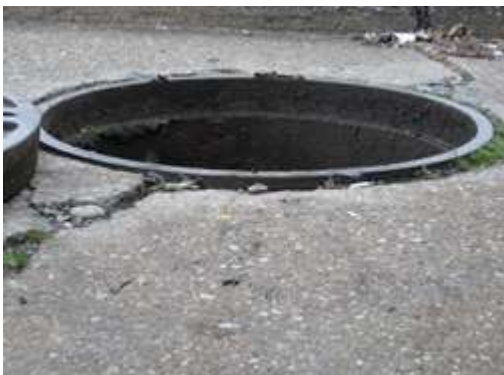
Defect 1

Cover Shape: **Circular** Diameter: **24** (in.) Length: (in.) Dist A/B Grade: **0.5** (in.)

Above grade

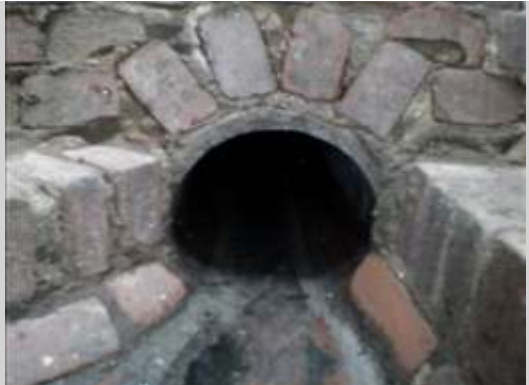
12 O'Clock Outflow

8 in. Circular Gravity Sewer
Pipe Out @ 12 O'Clock

Pipe Height: **9.6** (in.) Rod and Bar (Angled)
Pipe Material: **Clay** ☐ Pipe Lined
Invert Depth: **7.57** (ft.) Flow Characteristics: **Fast**
Deposits: ☒ None ☐ Mud ☐ Sludge ☐ Debris ☐ Grease
Silt Depth: (in.) Deposits Extent:
Infiltration: **None** Pipe Seal Cond: **Sound**

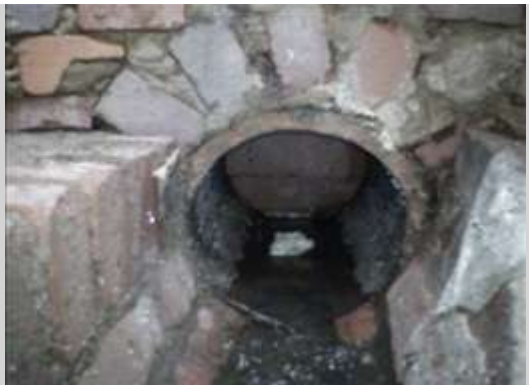
6 O'Clock Inflow

8 in. Circular Gravity Sewer
Pipe In @ 6 O'Clock

Pipe Height: **9.6** (in.) Rod and Bar (Angled)
Pipe Material: **Clay** ☐ Pipe Lined
Invert Depth: **7.67** (ft.) Flow Characteristics: **None**
Deposits: ☒ None ☐ Mud ☐ Sludge ☐ Debris ☐ Grease
Silt Depth: (in.) Deposits Extent:
Infiltration: **None** Pipe Seal Cond: **Sound**

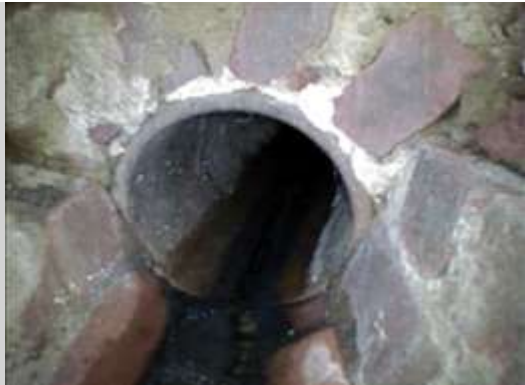
7 O'Clock Inflow

8 in. Circular Service Sewer
Pipe In @ 7 O'Clock

Pipe Height: **7.2** (in.) Rod and Bar (Angled)

Invert Depth: **7.29** (ft.) Flow Characteristics: **None**

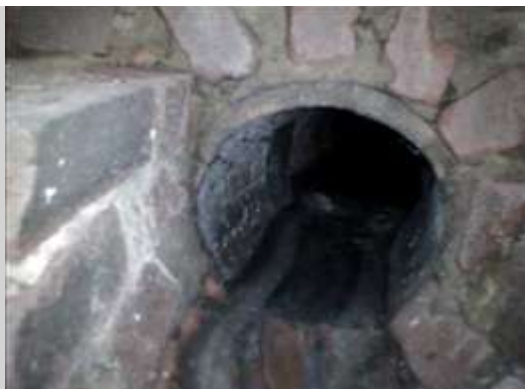
9 O'Clock Inflow

8 in. Circular Gravity Sewer
Pipe In @ 9 O'Clock

Pipe Height: **10.8** (in.) Rod and Bar (Angled)

Invert Depth: **7.63** (ft.) Flow Characteristics: **Fast**
